Assessment of wind speeds based on damage observations from the Angus (Ontario) Tornado of 17 June 2014

**Assessment of wind speeds based on damage observations from the Angus
(Ontario) Tornado of June 17, 2014**

A tornado occurred in Angus, Ontario, during the late afternoon hours of June 17, 2014. The authors conducted a damage investigation on the morning following the storm. The damage indicators support the classification of the tornado as an EF-2, including the observation of several complete roof failures of recently-constructed, wood-frame houses. Most of the damage to residential homes was contained along two streets, with the tornado appearing to have gone down the backyards between the two. In total, 101 houses were observed to have sustained some level of damage. The evidence suggests that the quality of construction likely affected the performance of failed roofs. A detailed fragility analysis was conducted to assess wind speeds associated with these failures of the roof-to-wall connections. An overturned and lofted box truck provided the opportunity to correlate this failure with adjacent, repetitive failures of roof sheathing, shingles and garage doors.

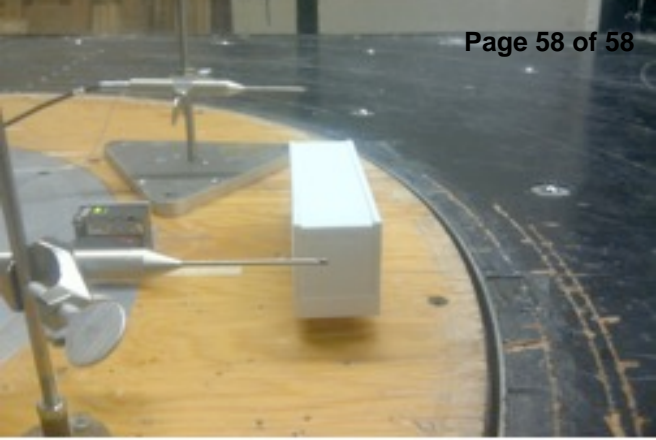
- Fig. 13. Photograph of the box truck model in the wind tunnel showing the set-up for the Cobra probes and displacement transducer.

Our interest here is to assess blow-over speeds for a box truck using the failure-model approach (Surry et al. 2005; Visscher and Kopp 2007). A model of the truck was constructed with rapid prototyping methods using a length scale, $\lambda_L = L_m/L_p = 1/50$ where L is a length, the subscript, m , represents model scale, and the subscript, p , represents the prototype (i.e., full scale). The nominal size of the truck at this scale is 196 mm by 49 mm in plan and 74 mm in height. A photograph of the model

is provided in Figure 13. The mass scale ($\lambda_m = M_m/M_p$, where M is mass) can be calculated as $\lambda_M = \lambda_\rho \lambda_L^3$. Here, the density scale, $\lambda_\rho = \rho_m/\rho_p = 1$. The full-scale mass of the box truck used for the tests was assumed to be 8260 kg, which represents a fully-loaded condition. For $\lambda_L = 1/50$ and $\lambda_\rho = 1$, this leads to a model-scale mass of 66 gm. It should be noted that the truck appeared to be empty before being lofted. Thus, the analysis below will consider the empty weight, which is assumed to be 5670 kg, or 45 gm in model scale, i.e., 69% of the test weight.

The current tests involved the overturning failure of a model truck placed on a plywood surface such that the model had the same friction coefficient as tires on asphalt. The wind tunnel speed was increased slowly until the vehicle slid or overturned, following the procedure developed by Visscher and Kopp (2007). Overturning failure was the primary mode of failure. In the simulated boundary layer flows, Cobra probe measurements were made simultaneously with a displacement transducer so that the gust speed at failure and an equivalent 3-sec speed could be determined directly from the recorded data. Equivalent, 3-sec gust wind speeds were obtained using the time scale relationships set by the use of the Froude scaling. Further details can be found in Stedman (2012). Twenty-five tests were conducted in each terrain configuration.
